ACCESSORY

S.5030
3000K CONVERSION FILTER

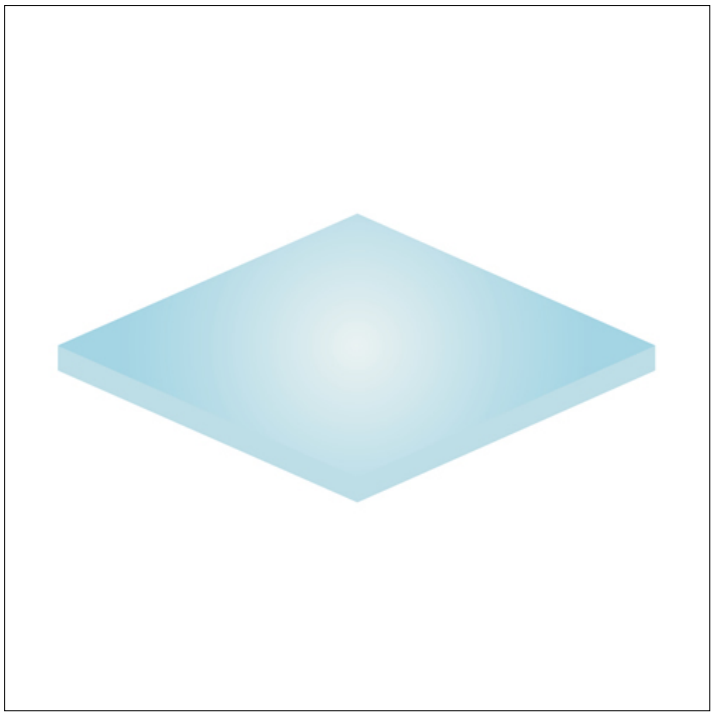
It is sometimes possible when installing the MEGALIFT with HIT-TC CRI 70W lamps onto a white wall, that there may be a difference in colour between the bottom light beam (~2700K) and the other (~3000K). This colour shift is caused by metal halide deposits forming on the bottom lamps arc tube, this problem can be corrected by installing the 3000K conversion filter inside the luminaire.
