ACCESSORY

S.5050
3000K CONVERSION FILTER

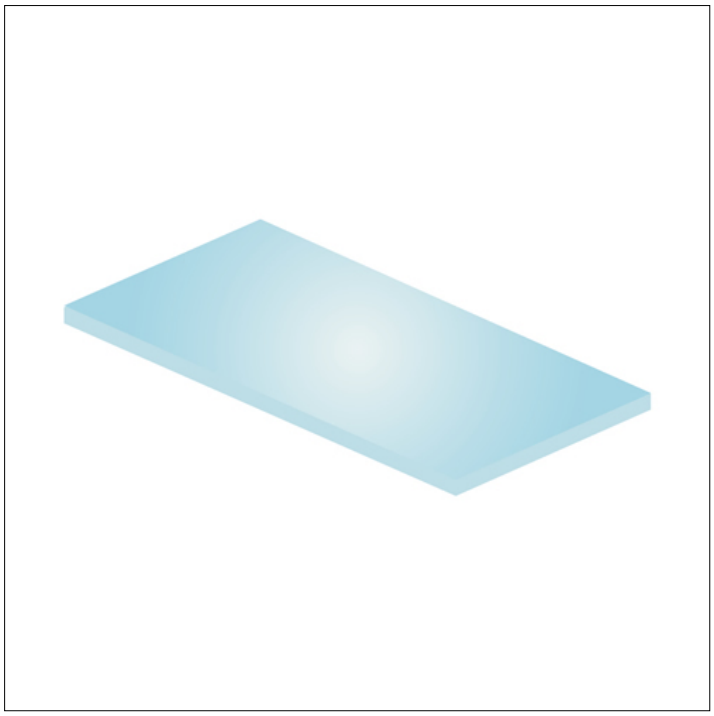
It is sometimes possible when installing the LIFT RECTANGULAR with metal halide lamps onto a whitewall, that there may be a difference in colour between the bottom light beam (~2700K) and the other (~3000K). This colour shift is caused by metal halide depositsforming on the bottom lamps arc tube, this problemcan be corrected by installing the 3000K conversionfilter inside the luminaire.
